HOBIT Technical Safety Bulletin No. 5-A

SUBJECT: Ohmeda Battery Charging Cradle

Issue Date: 9/18/19 **NOTE: Bulletin 5-A is a supplement and update to TSB No. 5**

DISCUSSION: USE OF THE NEW BATTERY CHARGING CRADLE TO REPLACE ALLIGATOR CLIPS

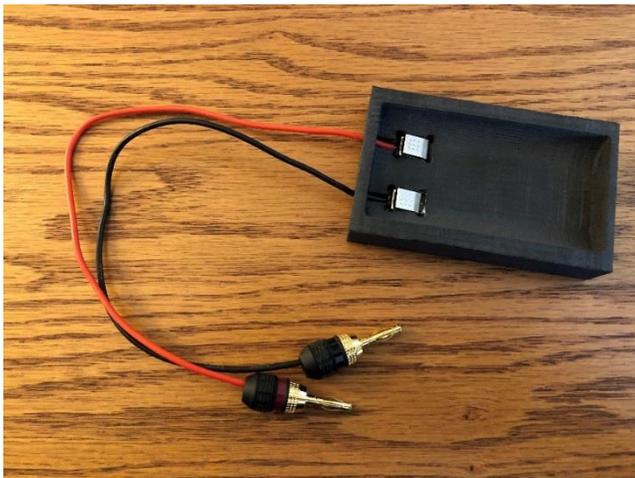
Fig. 1
New Charging Cradle

The initial procedure of connecting and disconnecting the Ohmeda battery pack via **alligator clips** to the charging unit has a risk of spark and possible injury to the user. To decrease this risk a battery charging "**Cradle**" (Fig. 1) is being supplied to each HOBIT site that is using the Ohmeda 5410 or 5420 Volume Monitor.

Use of the charging cradle will eliminate the need to connect the battery terminals via the alligator clips. It will also orient the positive and negative metal terminals correctly when the battery pack is placed into the cradle. Please remove the "Alligator" charging cables (Fig. 2) from the battery charger (Fig. 3) and dispose of them. The new charging cradle has a RED (positive) push-in banana connection that inserts into the RED female port on the side of the charging unit (Fig. 3 & 4) and a BLACK (negative) push-in banana connection which will insert likewise into the BLACK female port on the side of the charging unit (Fig. 3 & 4).

1. Initially connect the new charging cradle into the battery charger with the charger unit unplugged from AC power. After the cradle is connected the charger unit can be plugged into the AC wall outlet.
2. After inserting the new positive and negative banana connections into the charging unit, **always** leave the new cradle plugged in.
